# Intel® Xeon™ MP Processor

## Specification Update

*August 2003*

Document Number: 290741-018

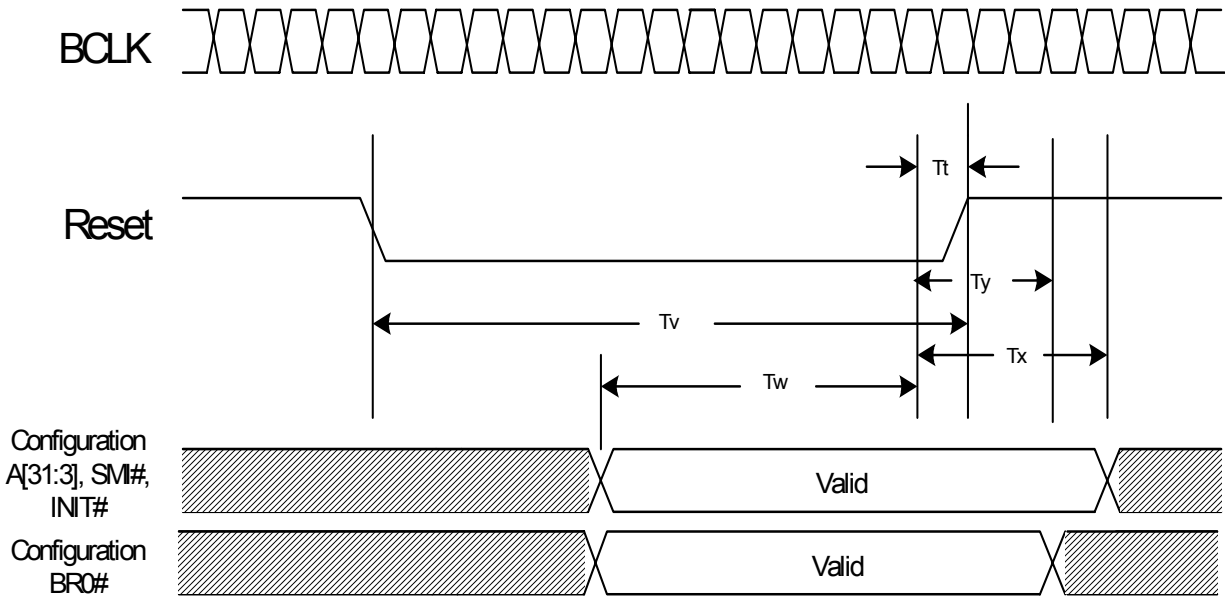
System Bus Reset and Configuration Timings

The BR0# maximum hold time has changed to 2 BCLKs. This change will be shown in the "System Bus AC Specifications (Reset Conditions)" table and "System Bus Reset and Configuration Timings" figure of the above mentioned datasheets. This change will be incorporated in the next revision of the above datasheets.

The following figure will be modified to reflect this change:
